NAVAL AIR TEST CENTER TECHNICAL REPORT

FINAL REPORT

FLIGHT TEST EVALUATION OF THE UF-XS

JAPANESE STOL SEAPLANE (U)

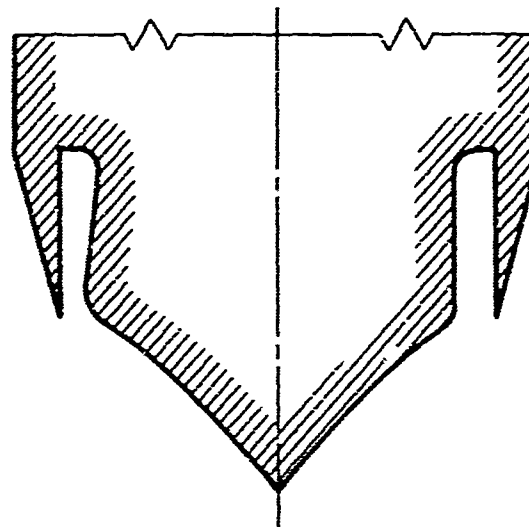
Figure 2
UF-XS Airplane Spray Suppressor Configuration, Looking Aft

8. The empennage was replaced with a T-tail configuration and the hull was converted to a high length/beam ratio hull (11.3) with long afterbody. The wing float displacement was increased from 43.6 ft³ to 60.0 ft³. A spray suppressor was incorporated in the hull forebody, Appendix IV, figure 2. This device is a recessed slot in the chine about six in. wide and 25 in. deep. It starts at the hull bow and continues to the propeller disc plane where it ends as an exit for the trapped water. The configuration of the spray suppressor differs on each side of the airplane as shown in figure 2.

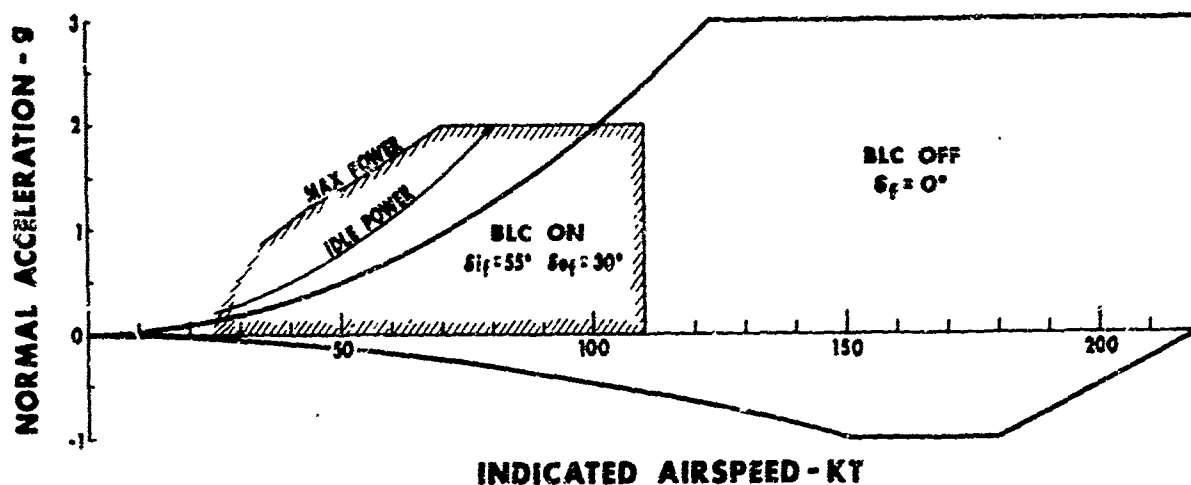
Figure 4
UF-XS Airspeed Versus Normal Acceleration

15. The airplane weight empty is approximately 28,600 lb. The basic flight design gross weight is 29,500 lb and maximum design gross weight is 35,400 lb. The structural CG limits are 15% MAC forward and 25% MAC aft. The CG limits for satisfactory flying qualities are 21% MAC forward and 25% MAC aft. The allowable airspeed-normal acceleration envelope of the UF-XS at 35,400 lb is presented in figure 4.

16. Nine flights and 13.9 flight hours were flown for quantitative and qualitative evaluation of the handling qualities and hydrodynamic characteristics of the UF-XS airplane within the BLC ON operating envelope shown in figure 4 for the stability configurations defined in Table IV.

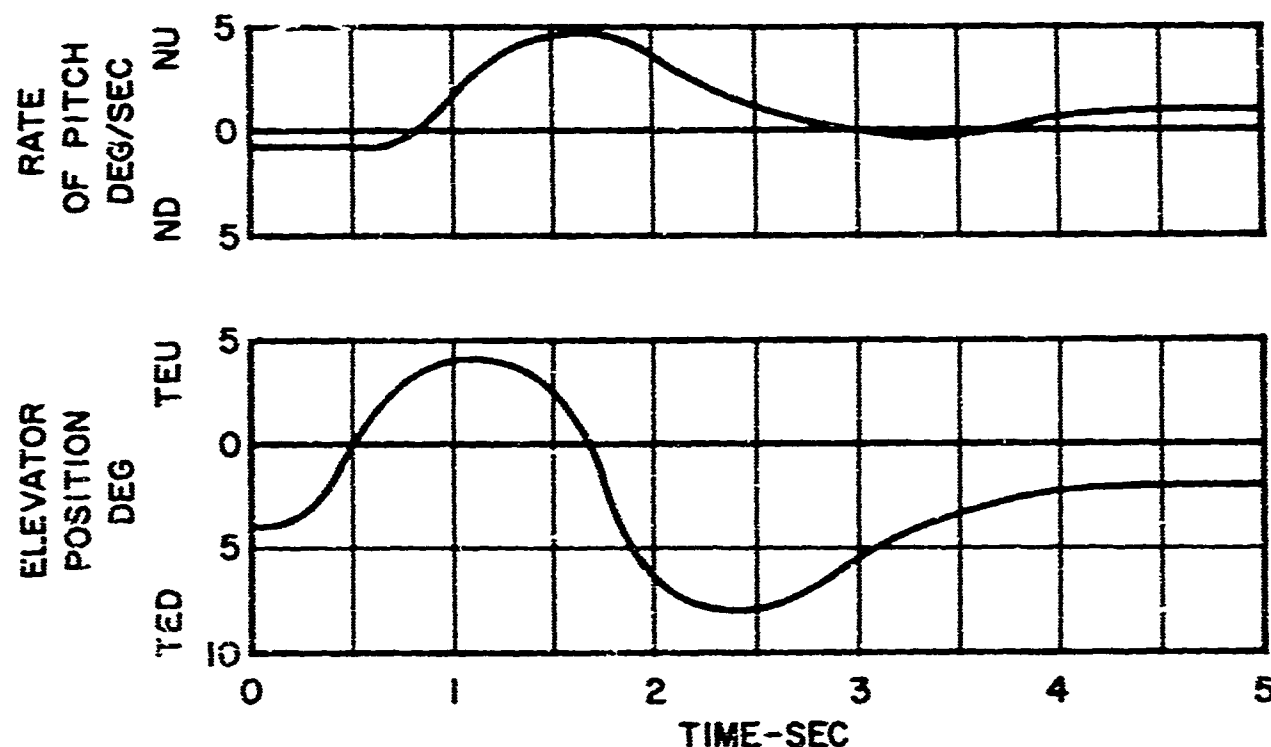
Figure 5
Airplane Short Period Oscillation with ASE ON

40. The ASE provides both attitude stabilization and rate damping about the pitch axis and completely modifies the basic airplane longitudinal characteristics. With the controls released the ASE will hold the airplane in the pitch attitude established by the trim system. An elevator pulse input will momentarily displace the airplane in pitch; and upon release, the airplane will return to approximately the original attitude with a slight overshoot, as shown in figure 5. An elevator step

Trim Airspeed 55 kt IAS
Gross Weight 32,000 lb
CG Position 22% MAC
Altitude 5,000 ft

input will displace the airplane in pitch to a new attitude with a similar motion. The period of the response is such that it can lead to a pilot induced oscillation (PIO) during a pitch maneuver either in flight or on the water during

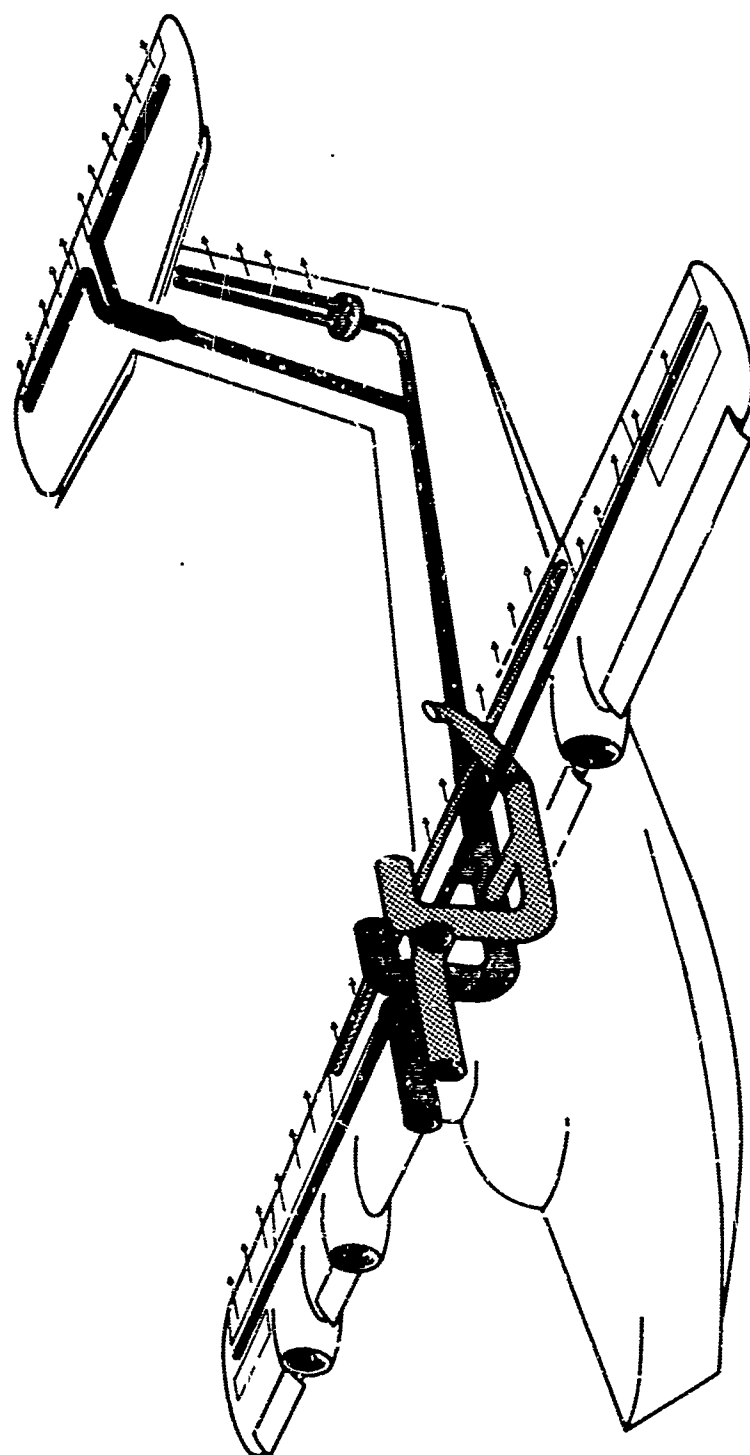
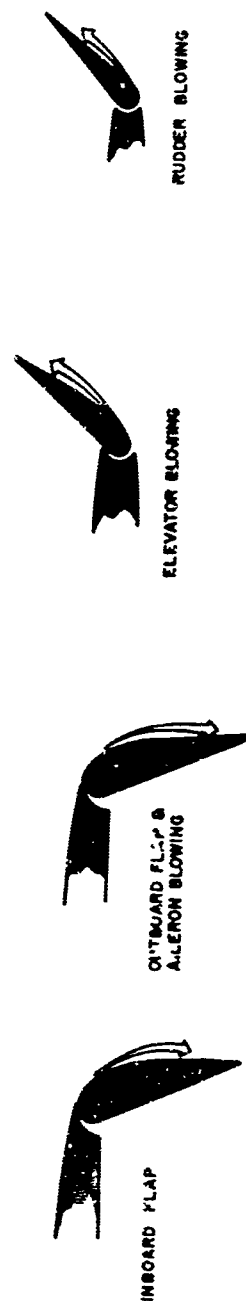
UF-XS Airplane
BOUNDARY LAYER CONTROL SYSTEM

12. A BLC system for slow speed operation was installed above the cockpit, Appendix IV, figure 3. The system supplies blowing air for the inboard and outboard flaps and all control surfaces. It is powered by two General Electric T58-GE-6A turboprop engines rated at 1250 SHP each driving an Isikawajima Harima Heavy Industries BLC-C-1 aft intake compressor. A schematic of the BLC system is contained in Appendix III, figure 3. The left engine/compressor supplies blowing air for the inboard flaps while the right engine/compressor supplies blowing air for the outboard flaps and all control surfaces. In the event of either BLC engine or compressor failure, the operative system will provide air to the outboard flaps and all control surfaces, and air to the inboard flaps is lost. Two types of blowing are utilized as indicated in Table I and illustrated in Appendix III, figure 3.

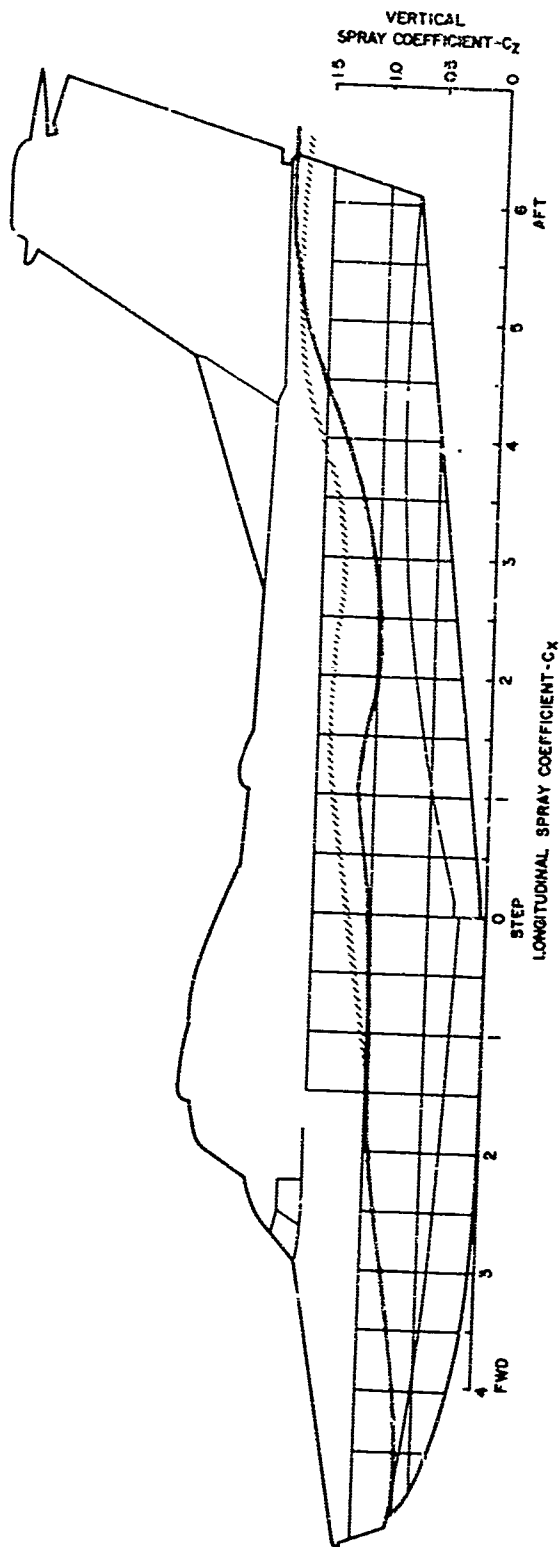
SPRAY CHARACTERISTICS

Headwind Component 5 to 10 kt
Wave Height 0.5 + 1.0 ft
Gross Weight 33,000 lb
CG Position 22% MAC

BLC	FLAP DEFLECTION
ON	55°/30°
OFF	32°/18°

49. When the BLC system is in operation on the water, the flow of air generated by the BLC system creates a water mist which circulates in rotary fashion about a transverse axis under the wing and extends spanwise the length of the flaps. The mist is light and does not pose a problem. At a constant speed of 38 kt IAS, with the BLC operating, medium spray was observed to pass through the propeller arcs with light spray passing over the wings. This spray characteristic also occurs during take-off but is less pronounced. The blunt shape of the bow caused some spray impingement on the windshield when taxiing into the wind in 1 1/2 ft waves.

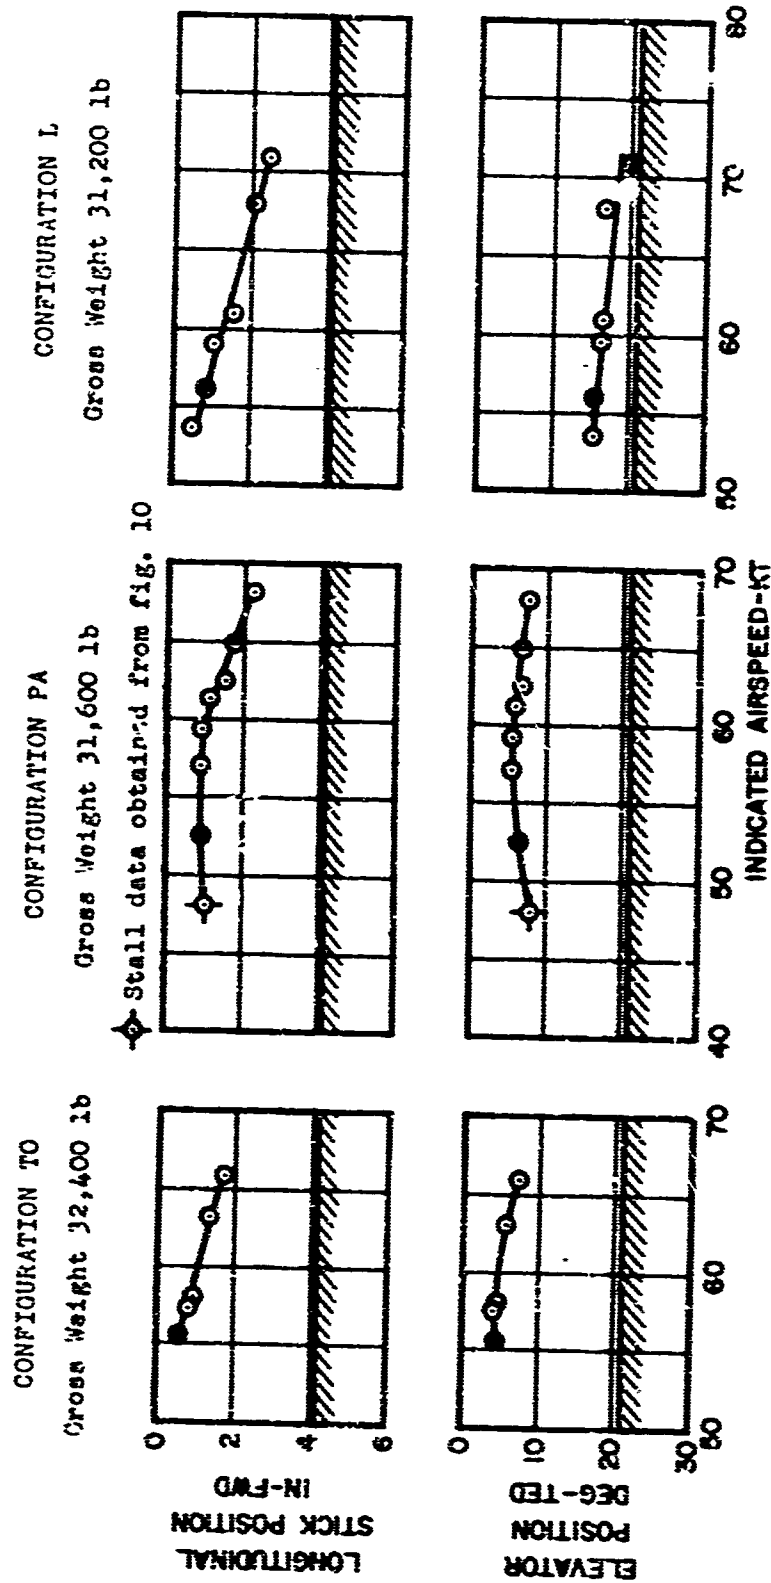
STATIC LONGITUDINAL STABILITY

BLC ON ASE ON
Flaps Deflected $55^\circ/30^\circ$
CG Position-22% MAC
Altitude-5,000 Ft

Control Position and Surface Limits
Solid Symbols Denote Trim Data Points

31. For configurations TO, PA, and L at a trim speed of 55 kt IAS, the elevator was positioned at 4°, 7° and 16° TED respectively, as shown in Appendix VIII, figure 1. At higher speeds where the airplane becomes stable, the elevator position moves closer to the TED limit. For configuration L, the elevator reaches the TED limit at approximately 75 kt IAS. At speeds below 55 kt IAS, the airplane tends to become unstable and the elevator again moves toward the TED limit, although for the test conducted the limit was not reached.

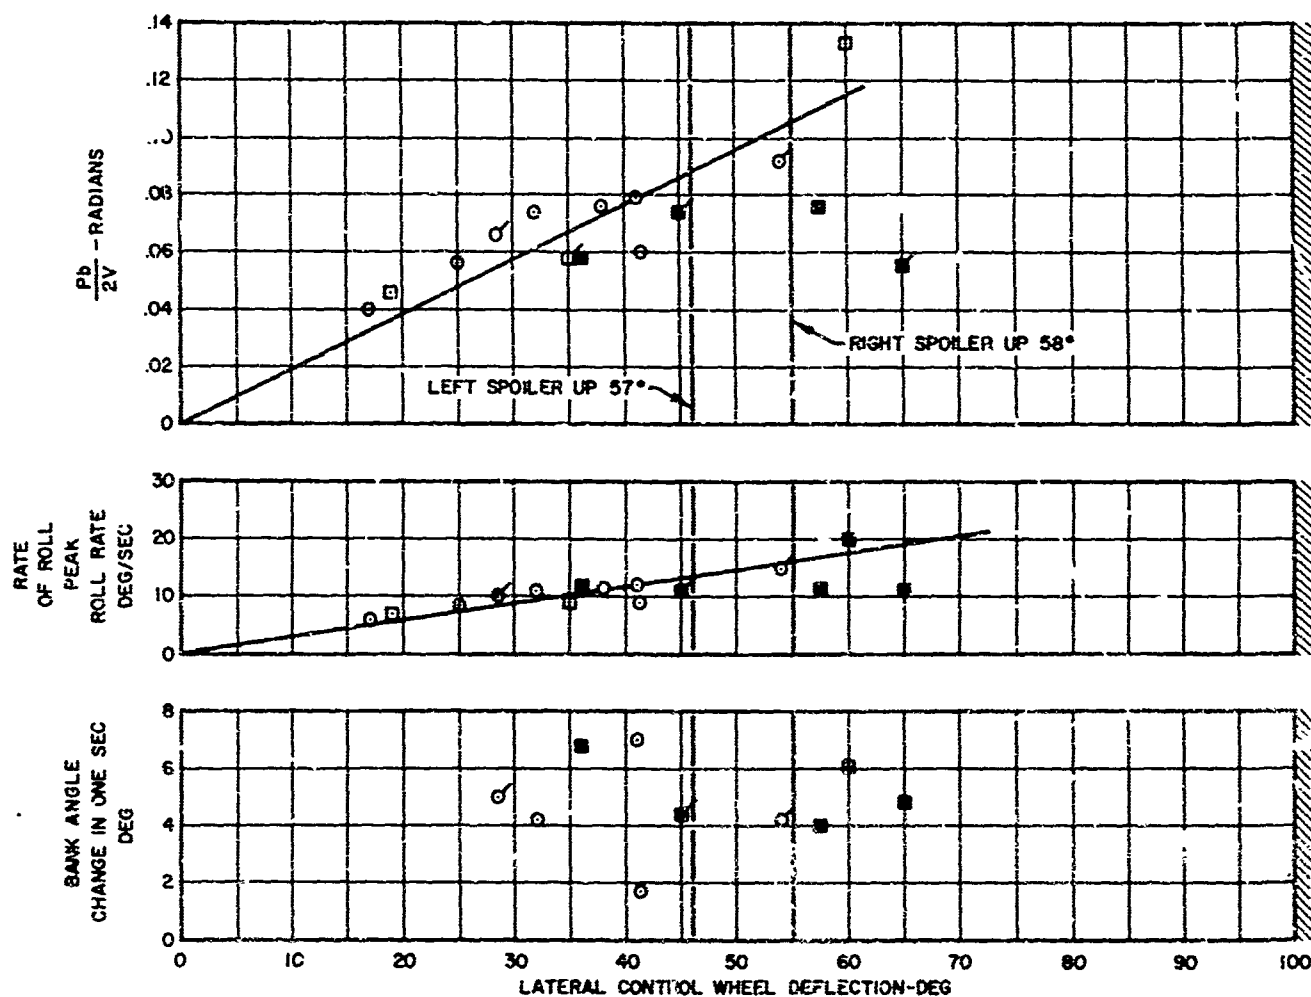
LATERAL CONTROL EFFECTIVENESS

Symbol	Conditions
○	Rudder Fixed
□	Rudder Coordinated
—	ASE ON
—	ASE OFF

Flagged Symbols Denote Left Rolls

//// Lateral Control Limit

at 55 kt IAS, lateral control wheel displacements for the tests ranged from 17° to 57° out of the total of approximately 100° available. Larger control wheel deflections were not used to avoid excessive and possibly uncontrollable adverse yaw effects (paragraph 37). The roll rates developed are linear with control wheel deflection as shown in Appendix VIII, figures 3 and 4. Limited tests at 70 kt IAS show the lateral control effectiveness to be slightly improved. The maximum roll rate developed meets the requirements of paragraph 3.4.16 of reference 5 (Cooper Rating 2); however, the bank angle change on second after initiation of lateral control is less than the 8° suggested by reference 6. The bank angle changes obtained during the tests utilizing 1/3 to 2/3 lateral control wheel deflection varied between 4° and 7° at 55 kt IAS and 4° and 8° at 70 kt IAS (Cooper Rating 3).

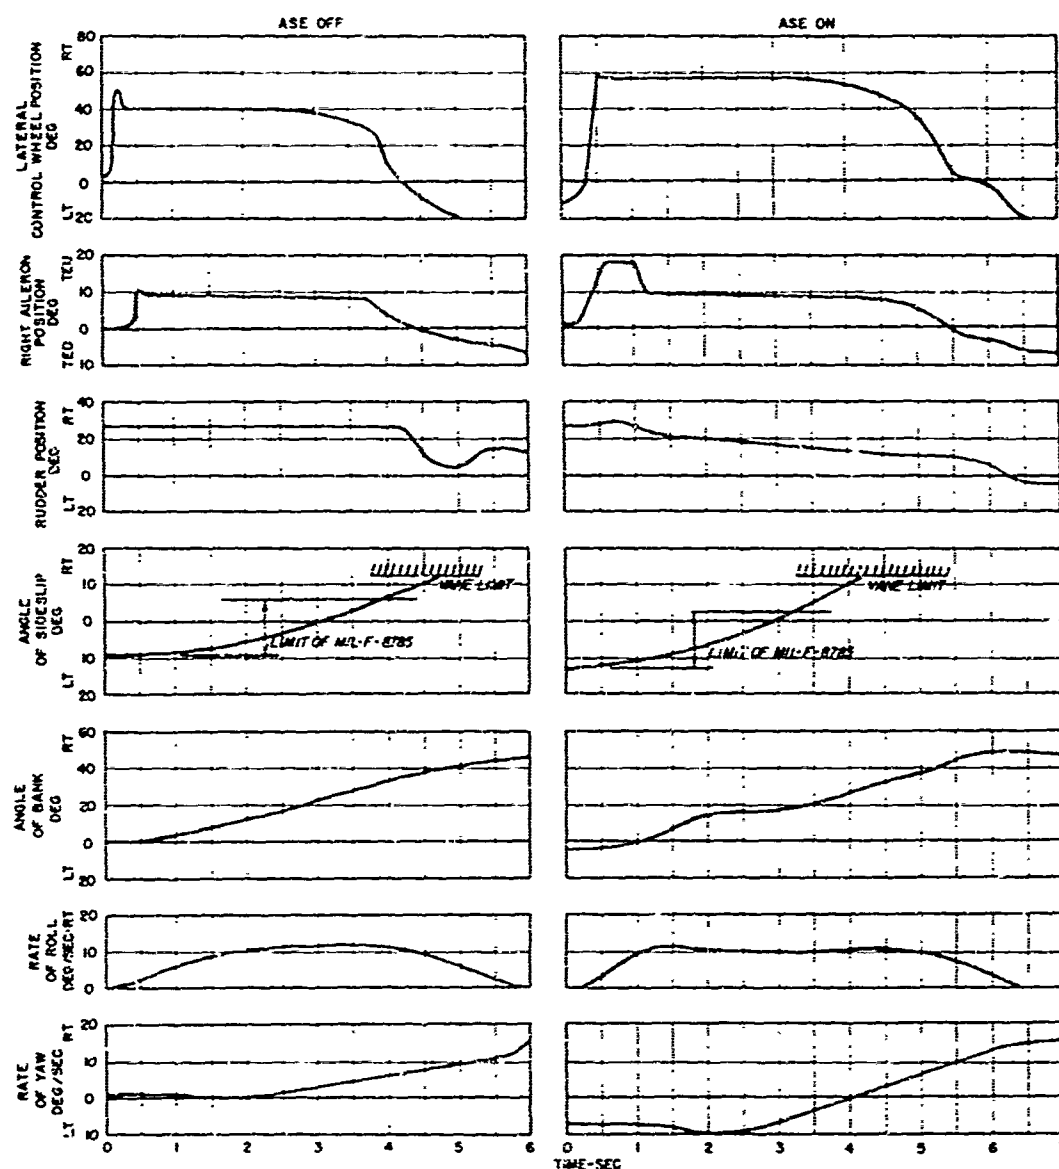
ADVERSE YAW DURING RUDDER-FIXED ROLLS

BLC ON
Flaps Deflected 55°/30°
Gross Weight - 31,000 Lb
CG Position - 22% MAC
Altitude - 5,000 Ft

37. Adverse yaw is extremely large and lateral control wheel deflections should be limited to angles less than 60° to avoid excessive sideslip angles (Cooper Rating 5). Maximum sideslip angles could not be measured because the sideslip measuring vane was limited to a travel of 21° to the left and 12° to the right. It is estimated that sideslip angles measured from the airplane center line in excess of 7° left and 43° right are obtainable with 1/2 lateral control wheel deflection at 55 kt. The sideslip angles developed exceed the 15° maximum limit set forth in paragraph 3.4.9 of reference 5. It is felt that larger lateral control deflections and/or larger step inputs would result in greater yaw rates and sideslip angles with possible loss of aircraft control. At a trim speed of 70 kt IAS, the sideslip angles were reduced only slightly. Time histories of the adverse yaw characteristics with the ASE OFF at 55 and 70 kt IAS are presented in Appendix VIII, figures 5 and 6.

42. The aileron rudder interconnect does not sufficiently reduce the adverse yaw which is still excessive, as shown in

Appendix VIII, figures 5 and 6 (Cooper Rating 4). The sideslip angles developed exceed the requirements of paragraph 3.4.9 of reference 5. The period of the lateral-directional oscillation is increased and the damping is decreased with the ASE ON when compared to ASE OFF operation. This degradation may be caused by adverse yaw generated from ASE deflection of the ailerons that lag the sideslip angle by 90° and thus reinforce the oscillation, as shown in Appendix VIII, figure 9. A comparison of the lateral-directional characteristics with ASE ON and OFF is presented in Table VI.

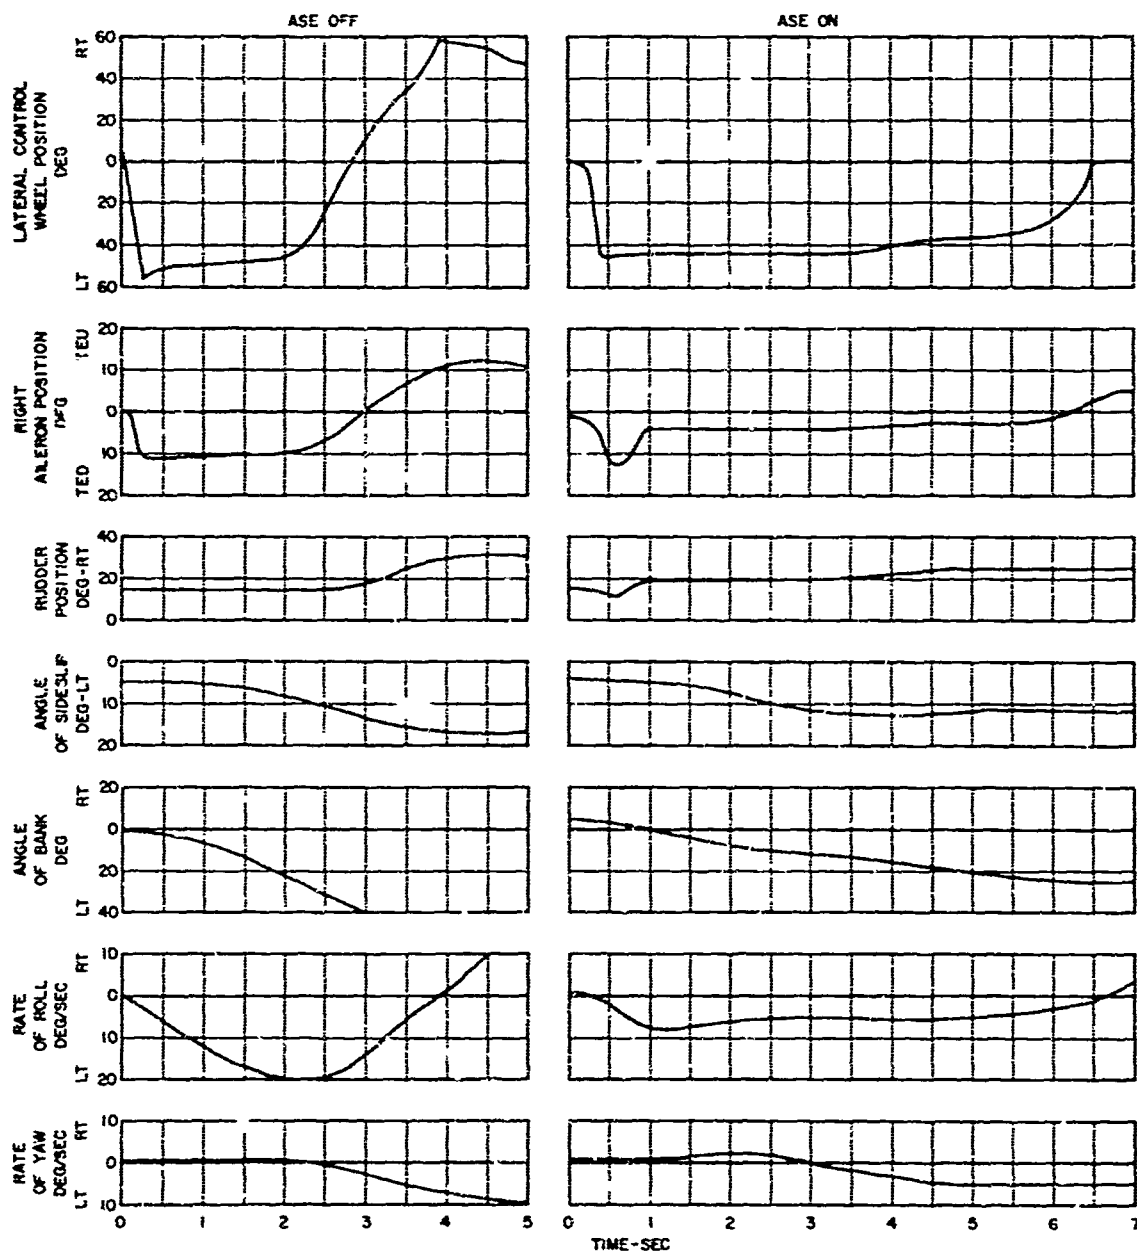
ADVERSE YAW DURING RUDDER-FIXED ROLLS

BLC ON
Flaps Deflected 55°/30°
Gross Weight - 31,000 Lb
CG Position - 22% MAC
Altitude - 5,000 Ft

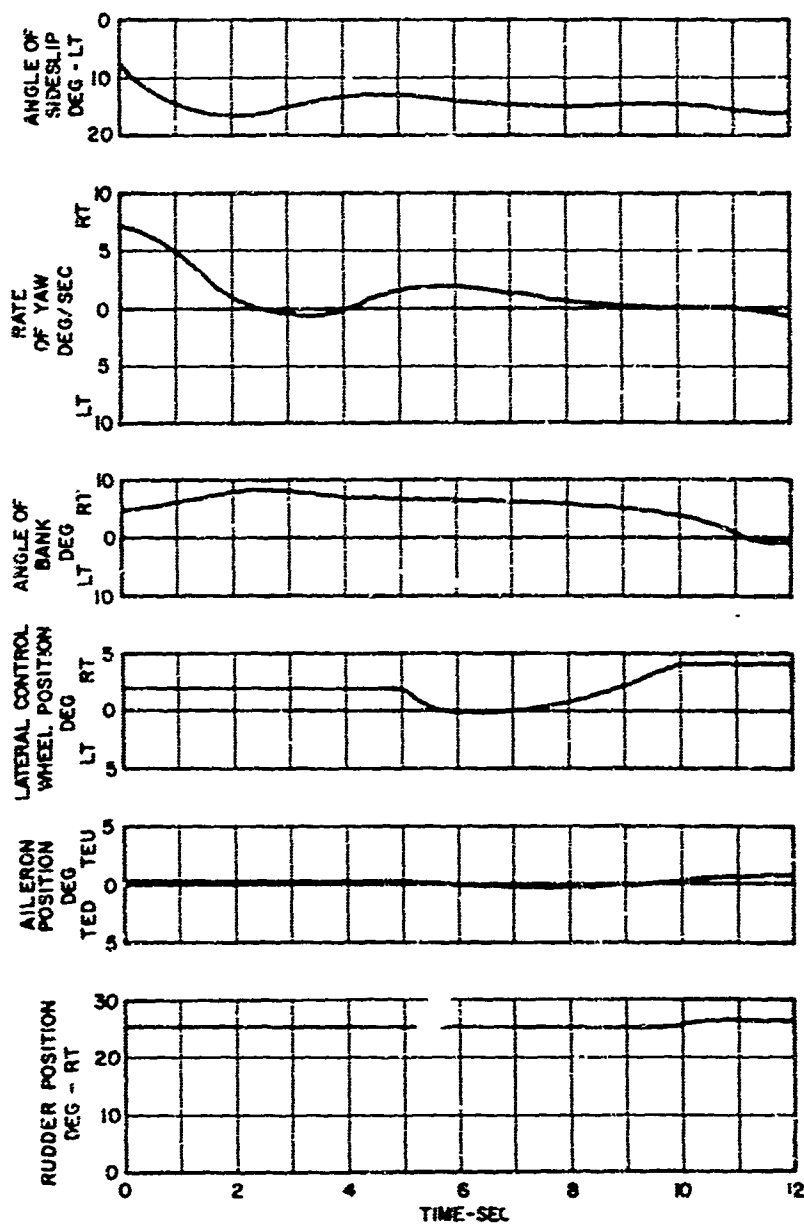
LATERAL-DIRECTIONAL OSCILLATION ASE OFF

BLC ON
Flaps Deflected 55°/30°
Gross Weight - 32,300 Lb
CG Position - 22% MAC
Altitude - 5,000 Ft

38. Dutch Roll tests resulted in a predominantly directional oscillation with a long period and medium damping (Cooper Rating 5). The period is 6 to 6.5 seconds. Time to damp to 1/2 amplitude is 4 1/2 to 5 seconds and 3/4 cycle, as shown in Appendix VIII, figure 7. Spiral stability tests were performed by trimming the airplane in straight flight and then releasing from bank attitudes displaced approximately 2° from trim. The airplane has strongly divergent spiral stability (Cooper Rating 5) with time to double amplitude of 2.7 seconds to the left and 3.7 seconds to the right, as shown in Appendix VIII, figure 8.

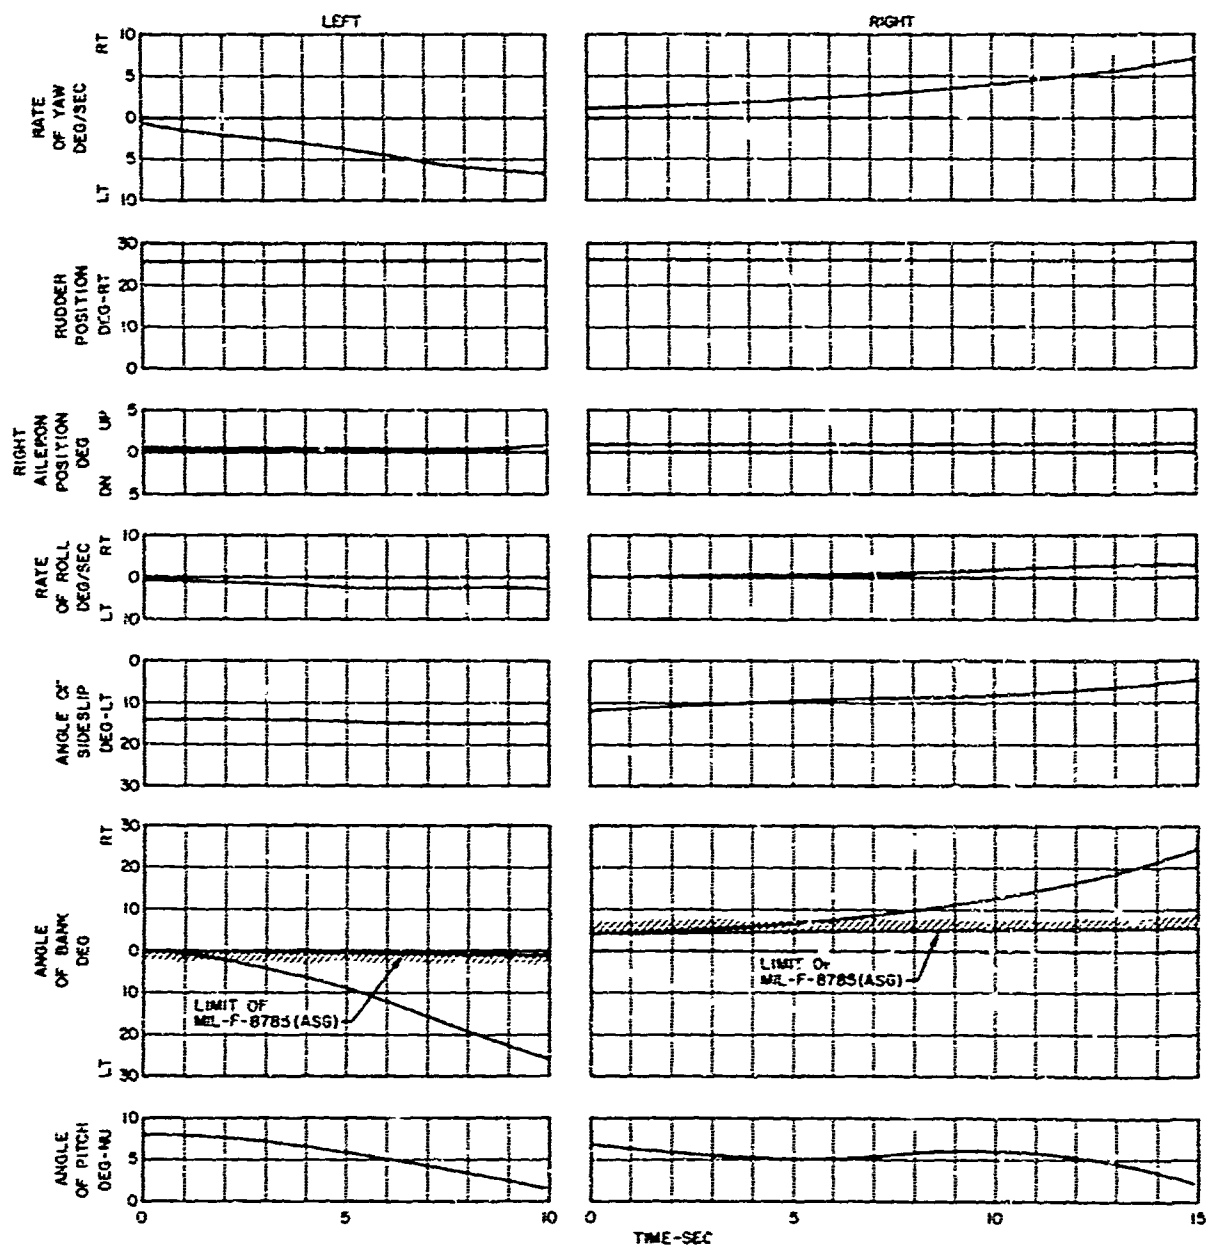
Figure 8
APPENDIX VIII

BLC ON
Flaps Deflected 55°/30°
Gross Weight - 32,000 Lb
CG Position - 22% MAC
Altitude - 5,000 Ft

UF-XS Airplane
SPIRAL STABILITY

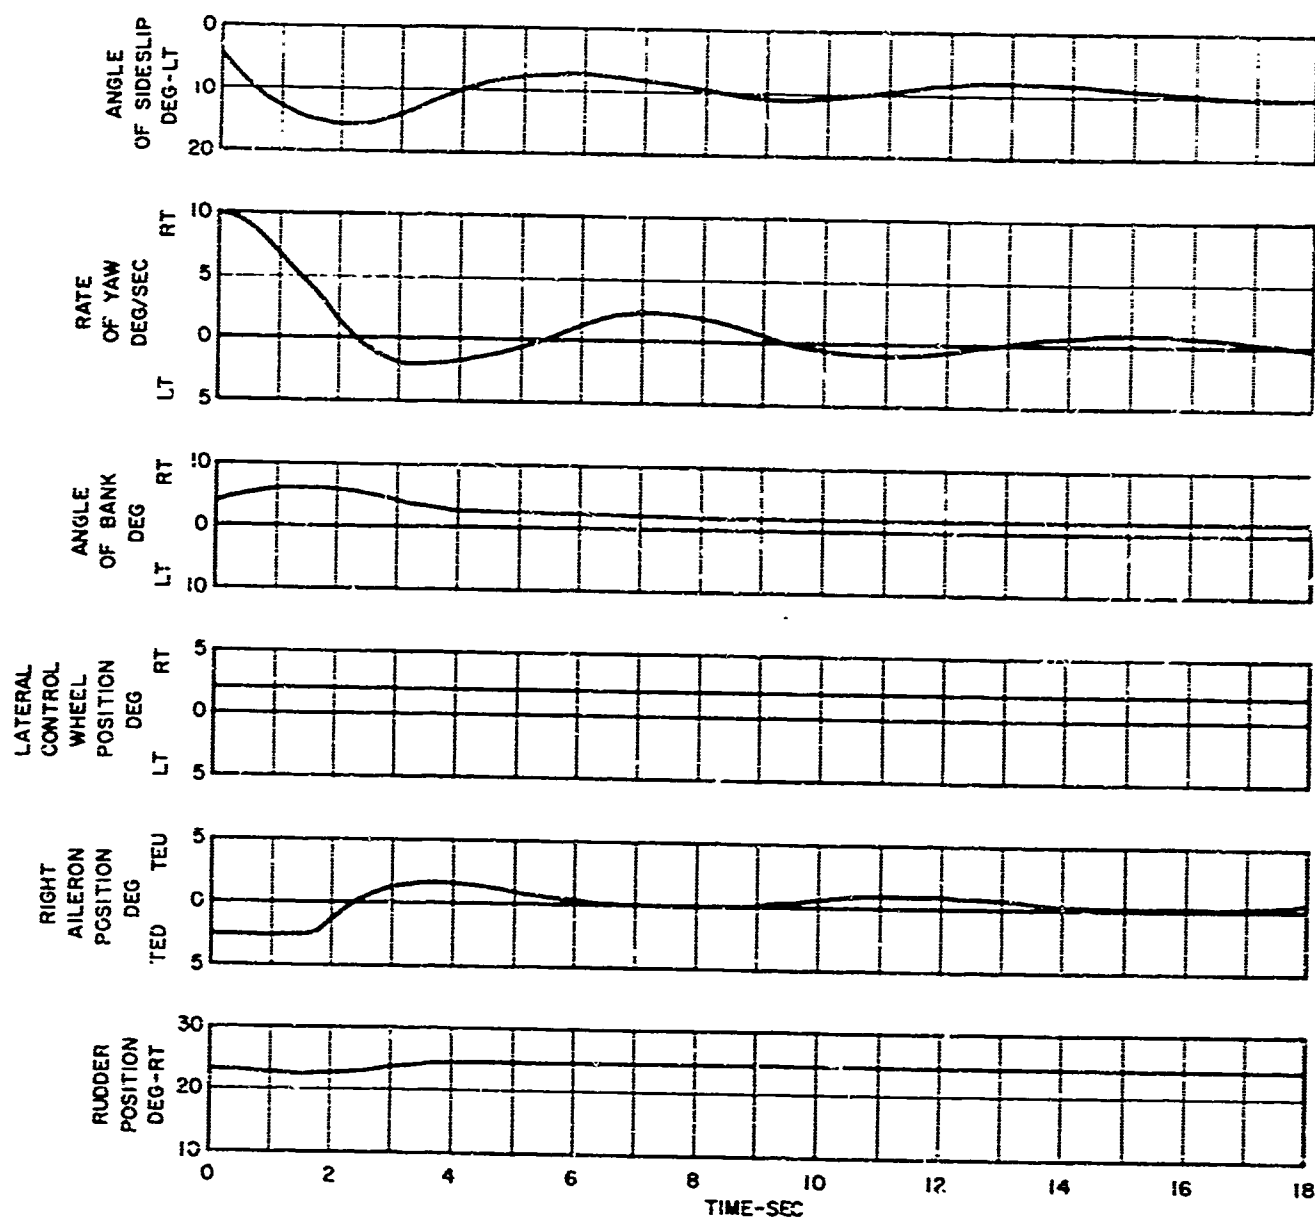
LATERAL-DIRECTIONAL OSCILLATION ASE ON

BLC ON
Flaps Deflected 55°/30°
Gross Weight - 32,300 Lb
CG Position - 22% MAC
Altitude - 5,000 Ft

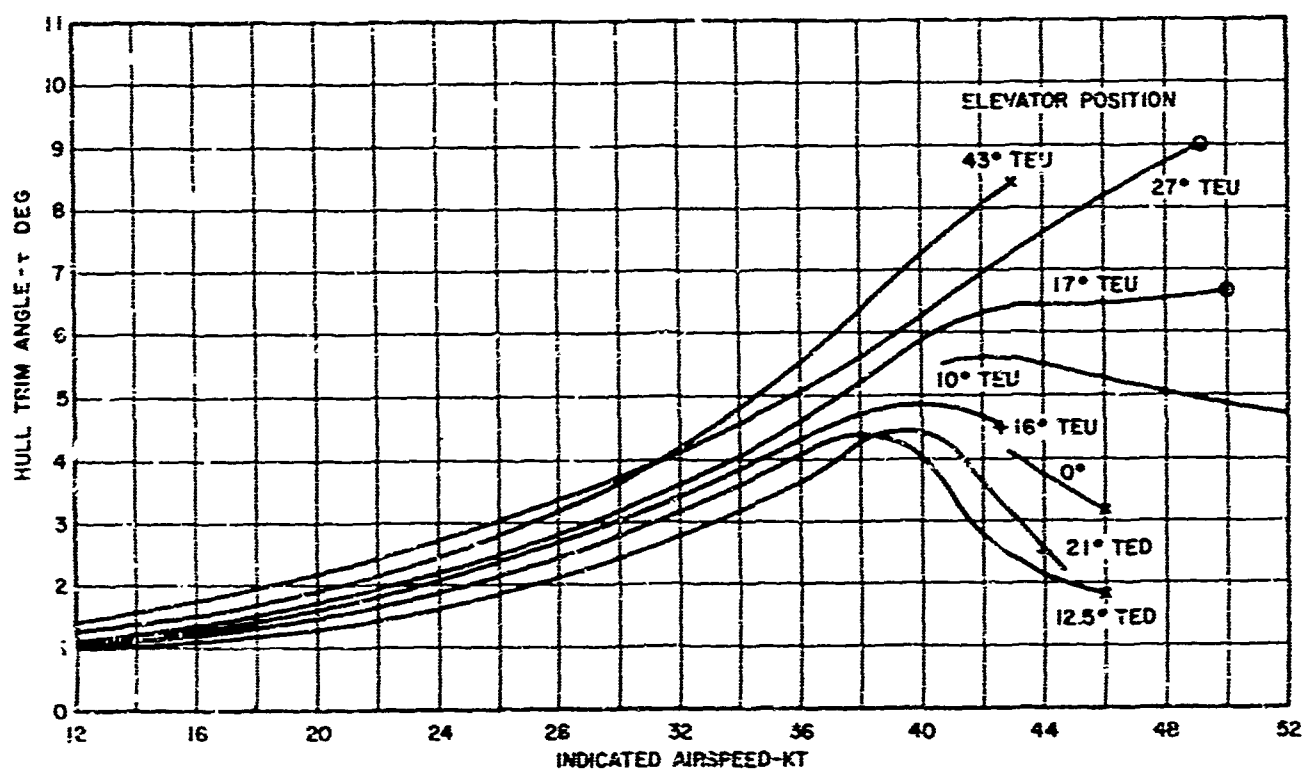
HYDRODYNAMIC LONGITUDINAL STABILITY

Flaps Deflected 55°/30°
 Gross Weight 33,000 lb
 CG Position 22% MAC

- X Power Cut
 O Take-Off
 + Abrupt Elevator Change

47. Limited hydrodynamic longitudinal stability tests were performed by making a series of take-offs in STOL operation with various fixed elevator settings, as shown in Appendix VIII, figure 11. The take-off run would continue until one of the following occurred: (1) two degree porpoise oscillation, (2) nose "dig-in," (3) speed stagnation, or (4) take-off. It was determined that the elevator range for stable take-off is 20 to 35 degrees up elevator. Elevator positions below 20 degrees result in the nose "digging in." Low elevator settings cause the "dig-in" to occur at lower speeds. At elevator settings ranging near neutral to 20 degrees, a porpoising action with approximately a three second period occurs. Speeds at which tests were terminated ranged from approximately 40 kt IAS for full down elevator to 45 kt IAS for 15 degrees up elevator. The elevator control was always sufficient to counter the "dig-in" and porpoise when the take-off was terminated. At elevator settings above 35 degrees, the airplane did not take off but assumed a slightly nose high attitude, and the speed stagnated at approximately 45 kt IAS. The hydrodynamic longitudinal control characteristics are good (Cooper Rating 2). The hydrodynamic longitudinal control effectiveness, obtained from the data of Appendix VIII, figure 11, is presented in Appendix VIII, figure 12.

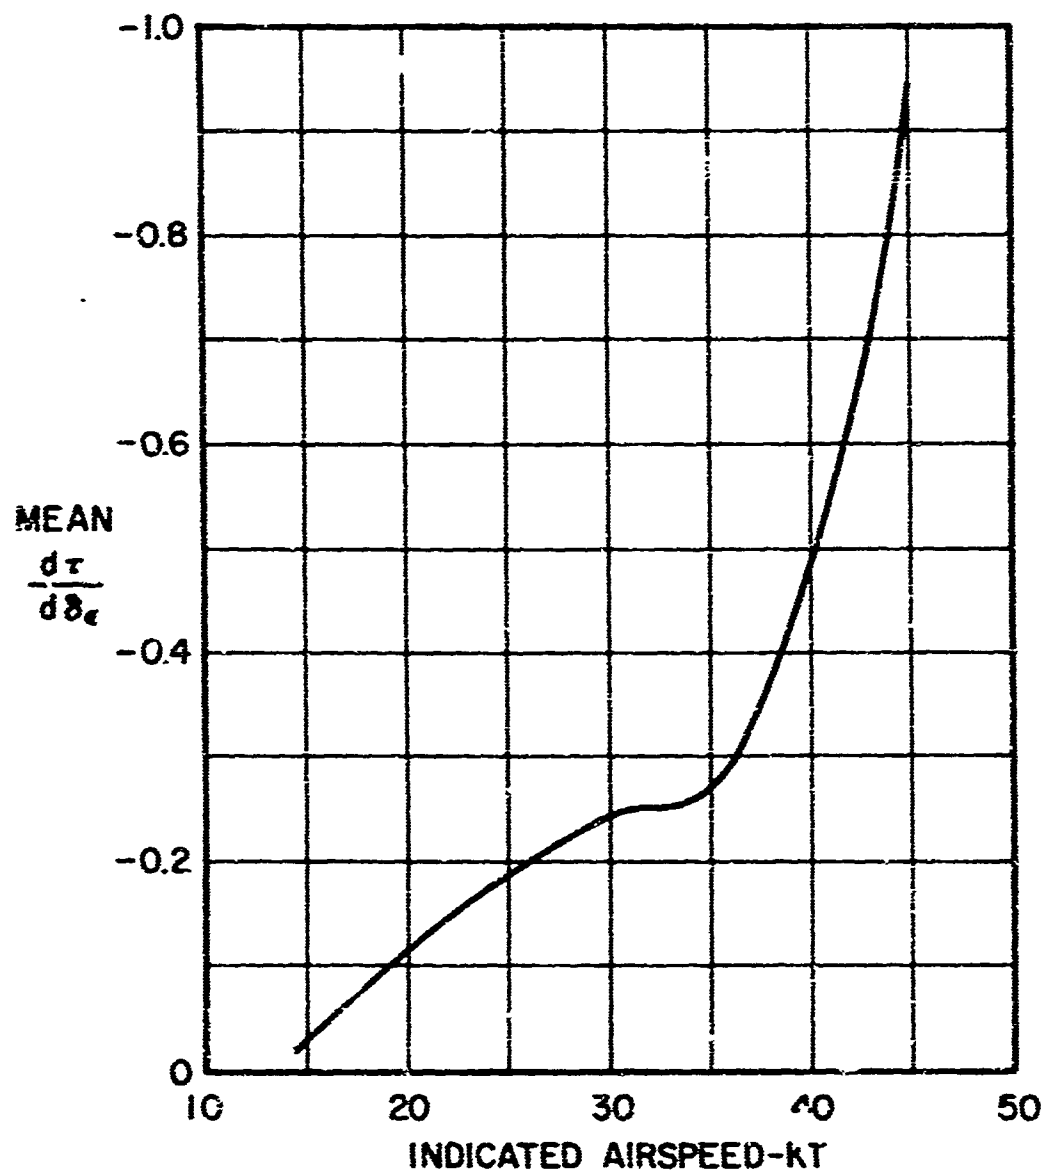
HYDRODYNAMIC LONGITUDINAL CONTROL EFFECTIVENESS

BLC ON ASE ON

Flaps Deflected 55°/30°
Gross Weight 33,000 lb
CG Position 22% MAC
